**RE: NOAA, EPA seek public comment on proposal to disapprove Oregon's Coastal Nonpoint Pollution Program**

*Rogue Riverkeeper comments RE: NOAA, EPA seek public comment on proposal to disapprove Oregon's Coastal Nonpoint Pollution Program*

**Agriculture Water Quality Management Program  
Compliance Investigation Reporting Form  
CI5**

# Little Butte Creek Bacteria Study 2011

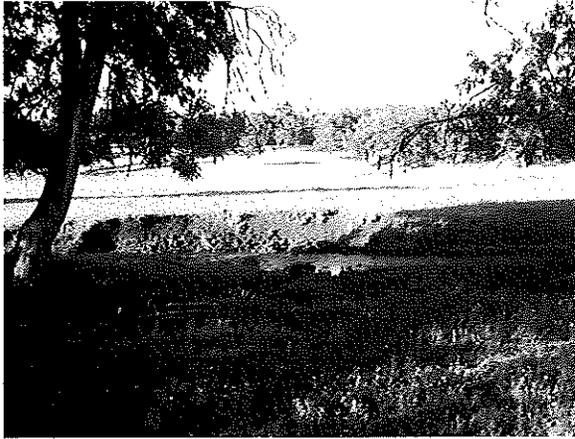
We noted livestock had trampled several areas along Dry Creek. This was particularly evident in and around the outflow of the in-stream dam, and at the south end of the property near the beginning of Transect #1. These are areas where the animals went to drink or crossed the creek to get to the pasture on the other side.

Figure 4. Bank conditions along Dry Creek near instream dam. Livestock damage. End of Transect #2.

Staff recommended contacting local SWCD for advice on pasture management and weed control.

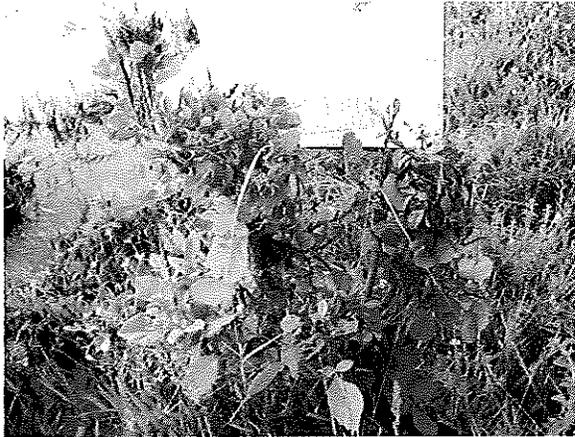
**Figure 5. Bank conditions at the beginning of Transect #1. Livestock crossing. Southern end of property facing north east.**

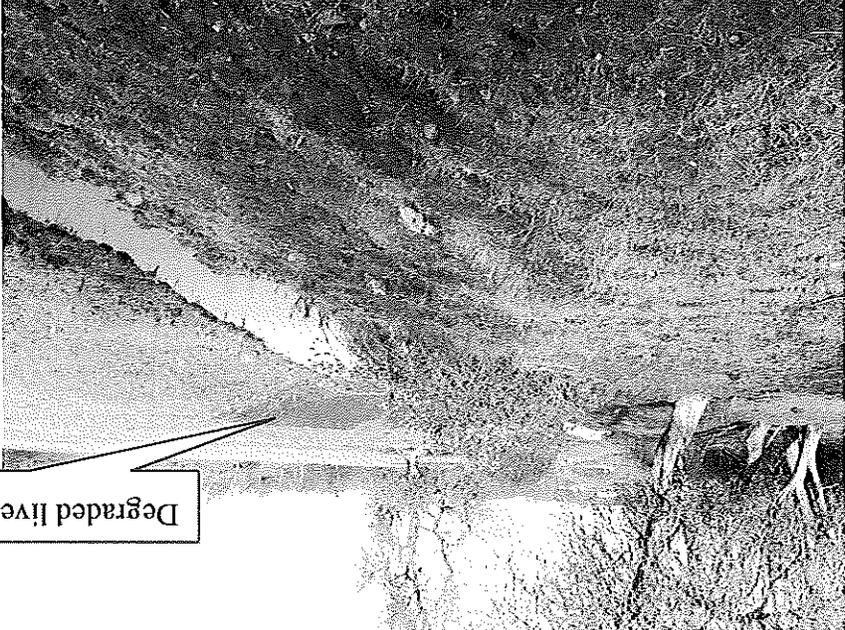
Photo #1: Looking north, downstream at upstream portion of riparian transect #1.

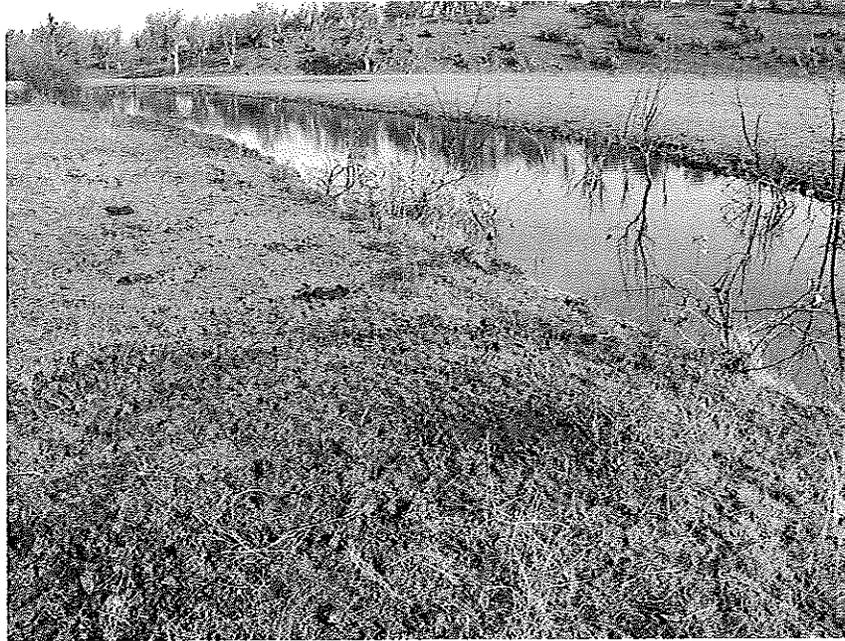
Photo #3: End of transect #1 showing lack of vegetation on both sides of creek.

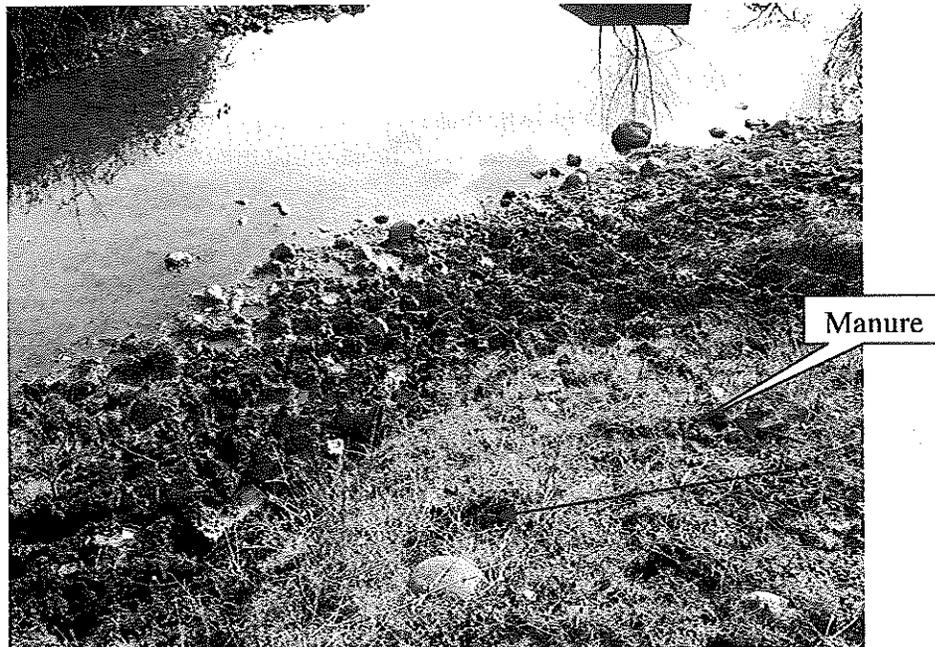
Photo #4: Middle of transect #2 showing livestock access point with deep mud with manure on embankment.

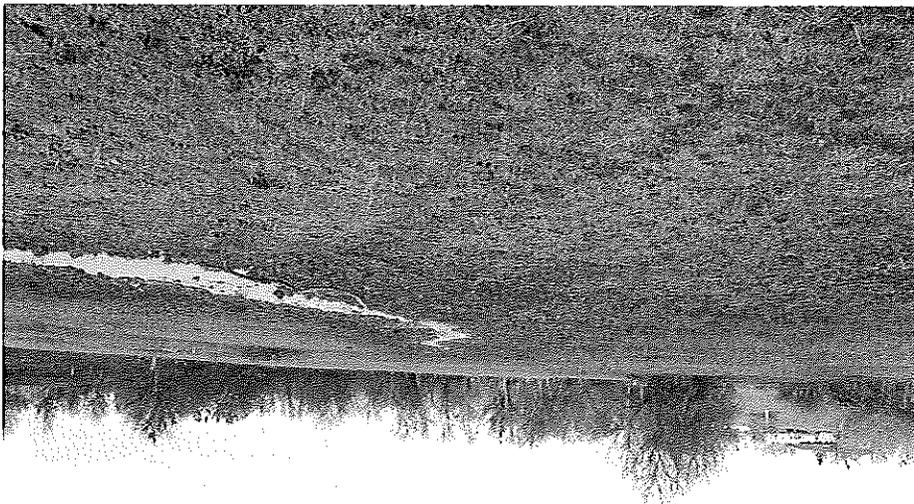
Photo #6: Looking away from creek, NNW, at t-posts that had held electric rope. Landowner stated electric rope was coiled at end of line of t-posts after the rope had been knocked down by livestock.

- Maintaining the temporary electric rope fence along Dry Creek, monitoring it so you restore it immediately if it is damaged or knocked to the ground.
- Applying for a Jackson Soil and Water Conservation District (SWCD) Land Owner Assistance grant to build a permanent livestock exclusion fence.

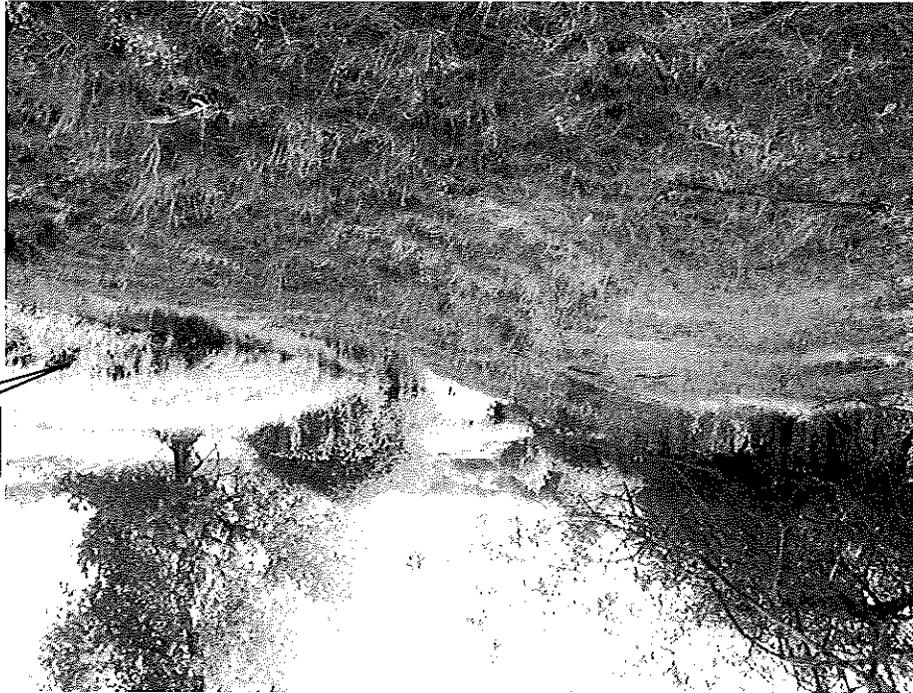
Bank erosion

Photo #1: Looking west, downstream, at beginning of riparian transect #1 showing state of riparian vegetation. Vegetation on top of streambank is highly grazed grass/weeds with no additional understory vegetation except for occasional patches of blackberries.

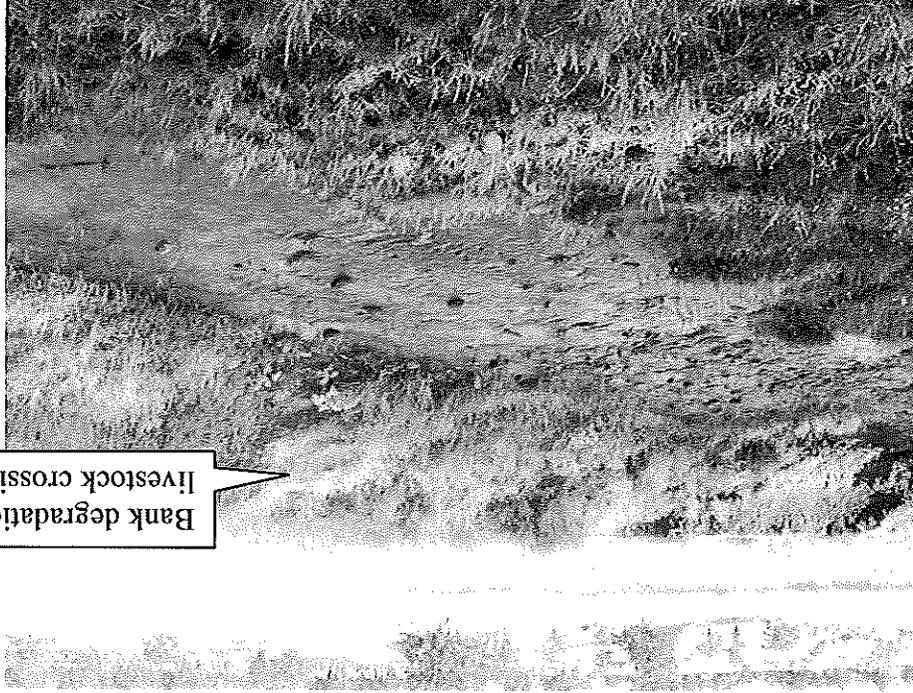
Bank degradation due to livestock crossing

Photo #2: Near beginning of riparian transect #1 showing degradation due to livestock crossing. Livestock have grazed and trampled streamside vegetation creating eroding bare ground or highly grazed grass with little other vegetation.

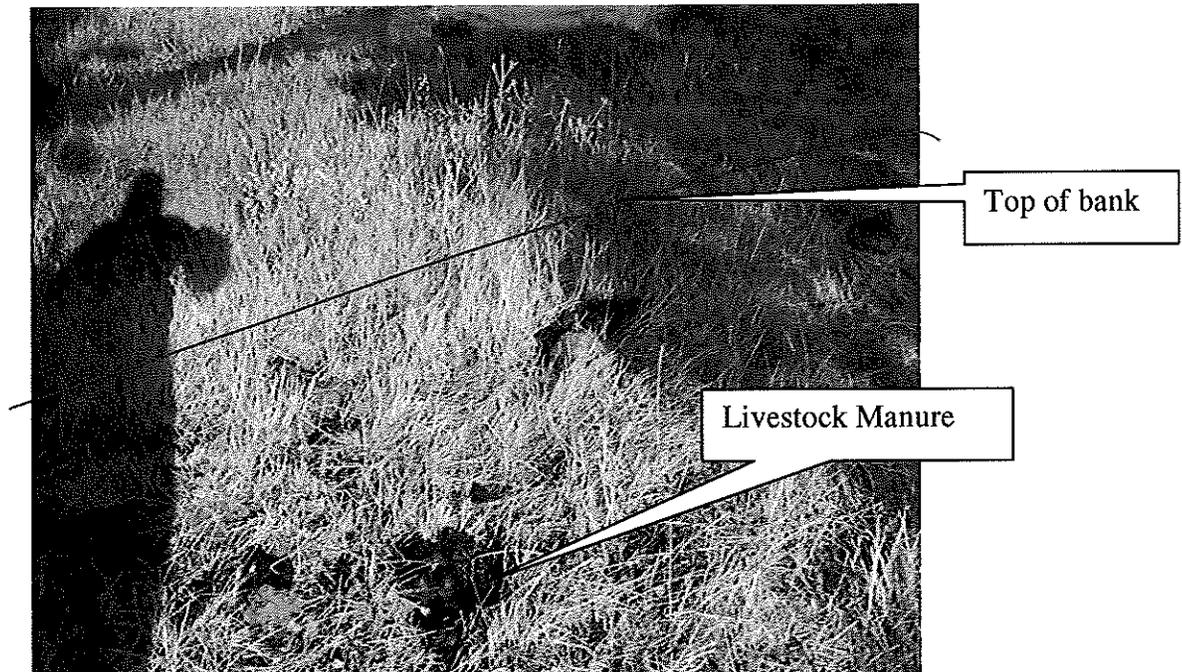
Photo #3: Top of bank showing dead or dormant grass and evidence of deposition of livestock manure. Note lack of any vegetation besides grazed grass/weeds and that green grass in channel is also grazed.

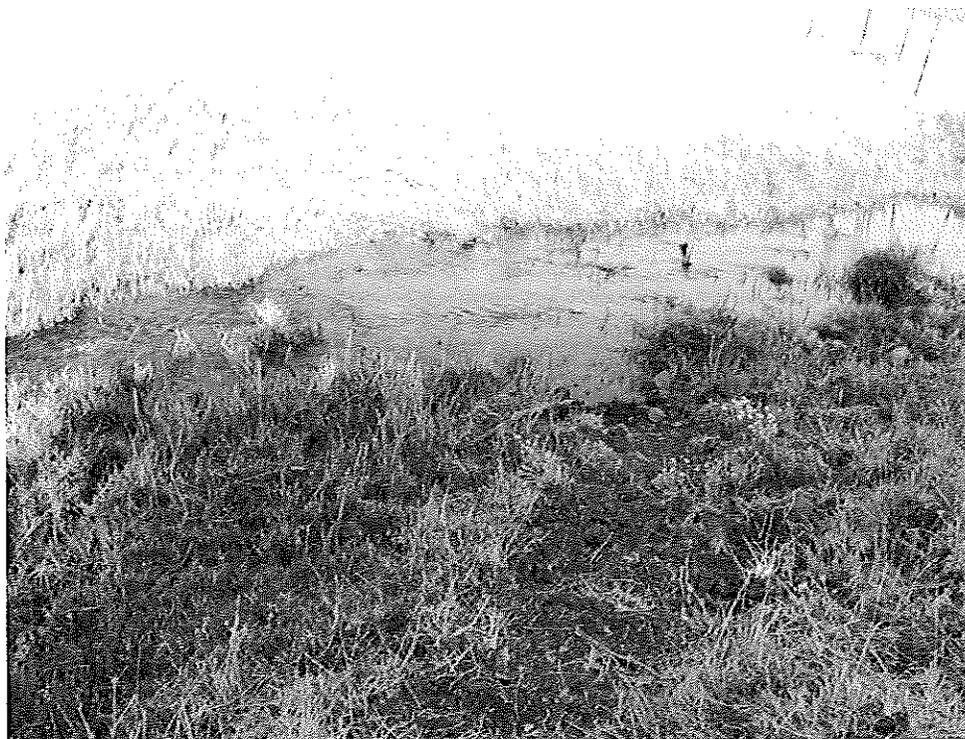
Photo #4: Near beginning of riparian transect #1 showing livestock crossing and lack of riparian vegetation. NRCS soil survey and nearby intact riparian areas show that wild roses, service berries, willow and ash trees, and a variety of forbs should be growing in this riparian area.

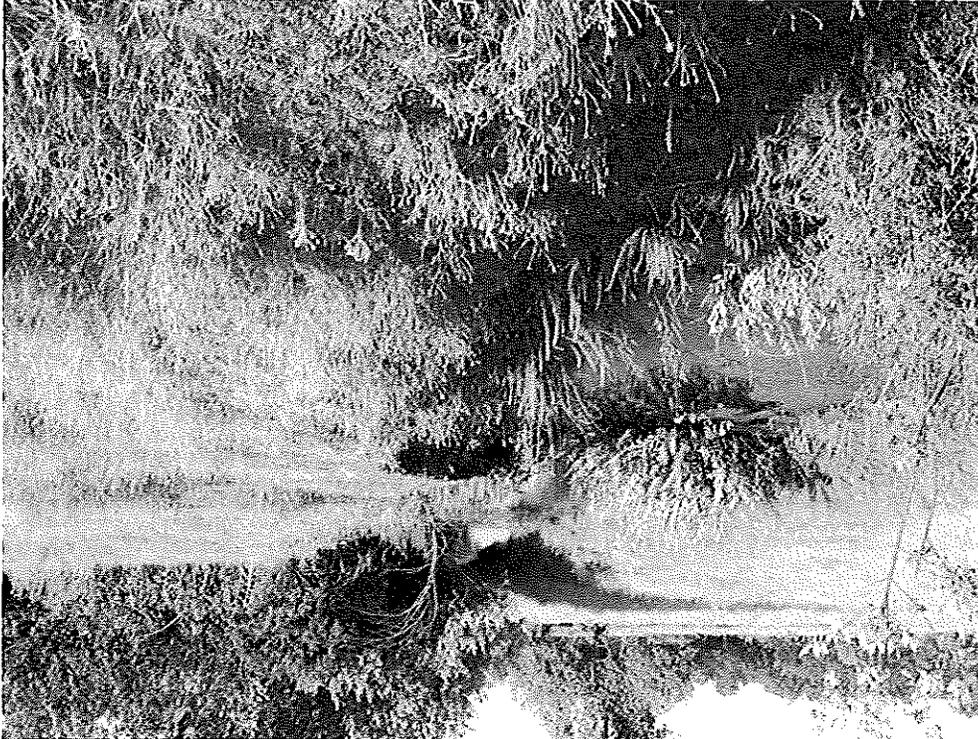
Photo #6: Looking east and upstream near middle of transect #2 showing lack of riparian vegetation. Unfinished fence is also shown.

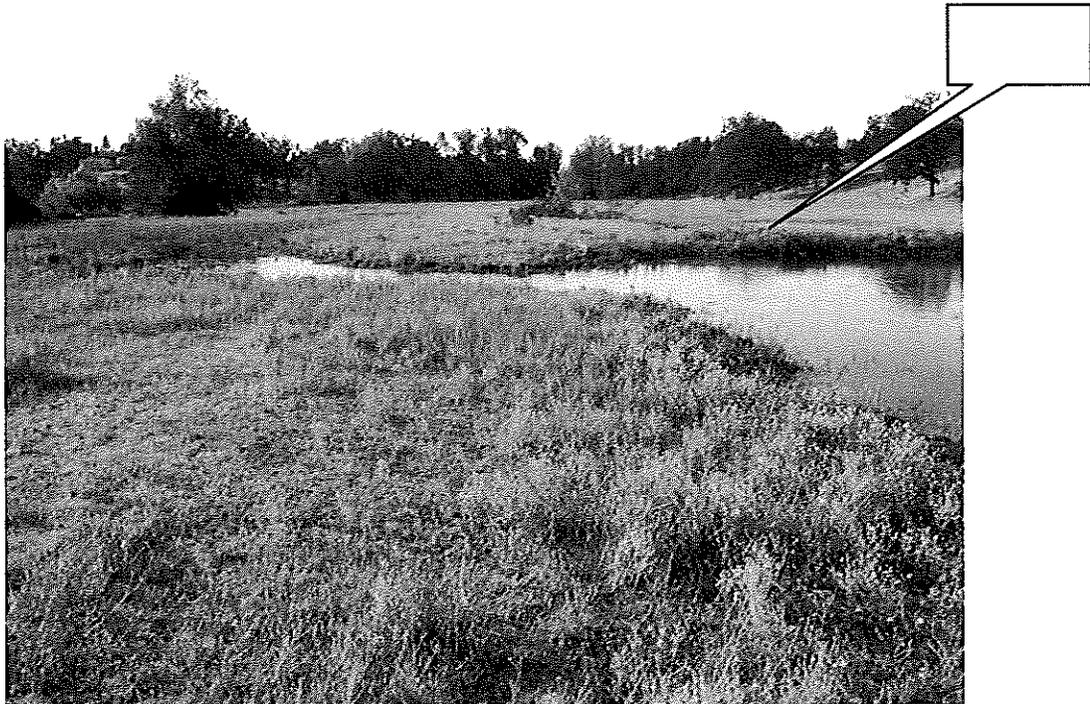
Photo #7: Near middle of riparian transect #2 looking westward and downstream showing lack of riparian vegetation. Dam is also shown.

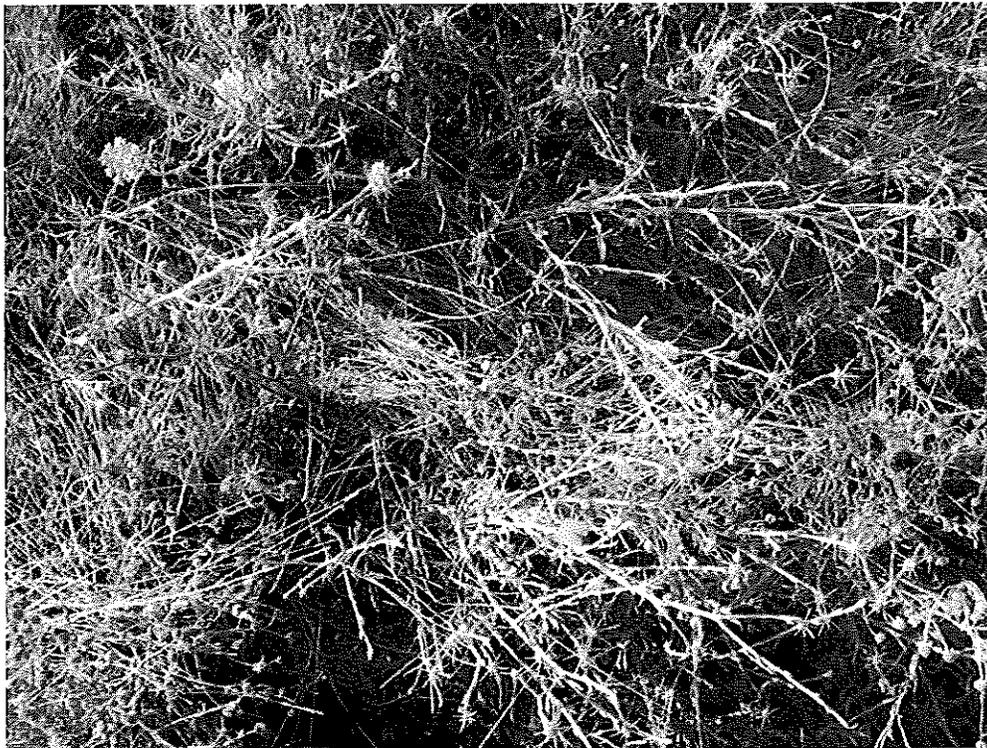
Photo #8: Typical remaining riparian vegetation along riparian transect #2 showing dead or dormant grass and noxious weeds.

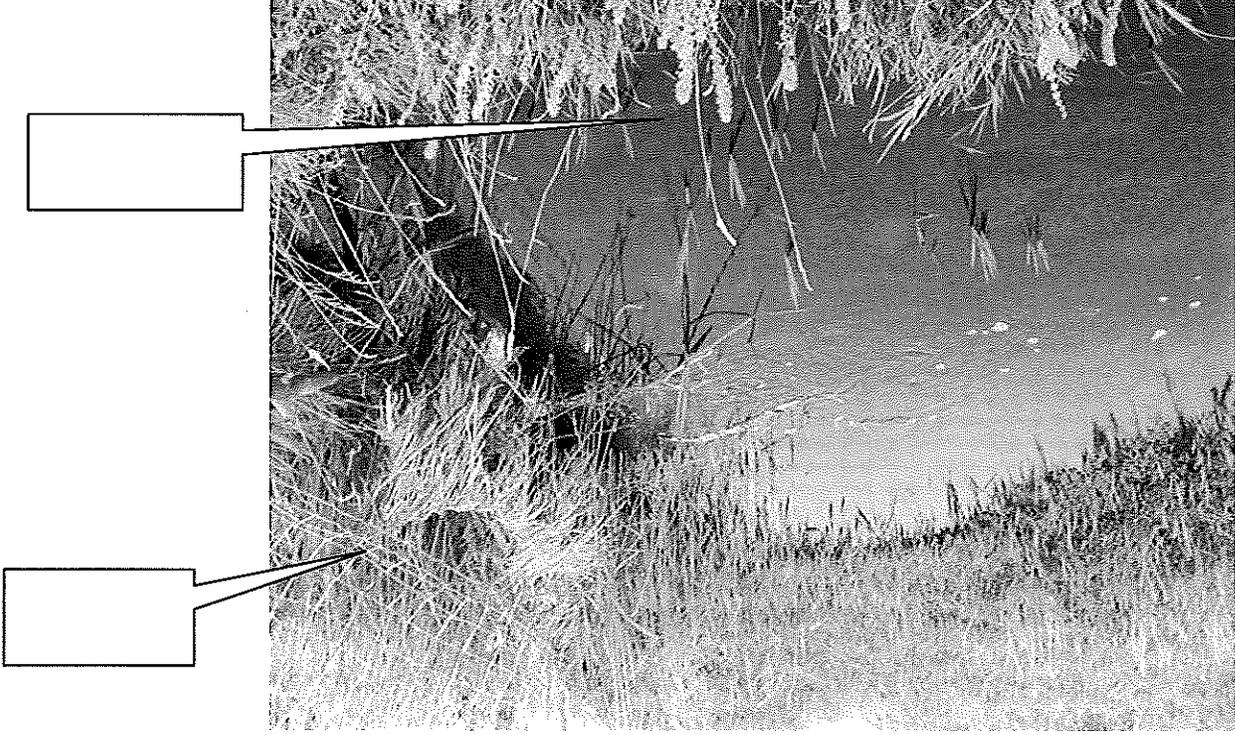
Photo #9: Dry creek near beginning of slack water above dam showing algae growth.

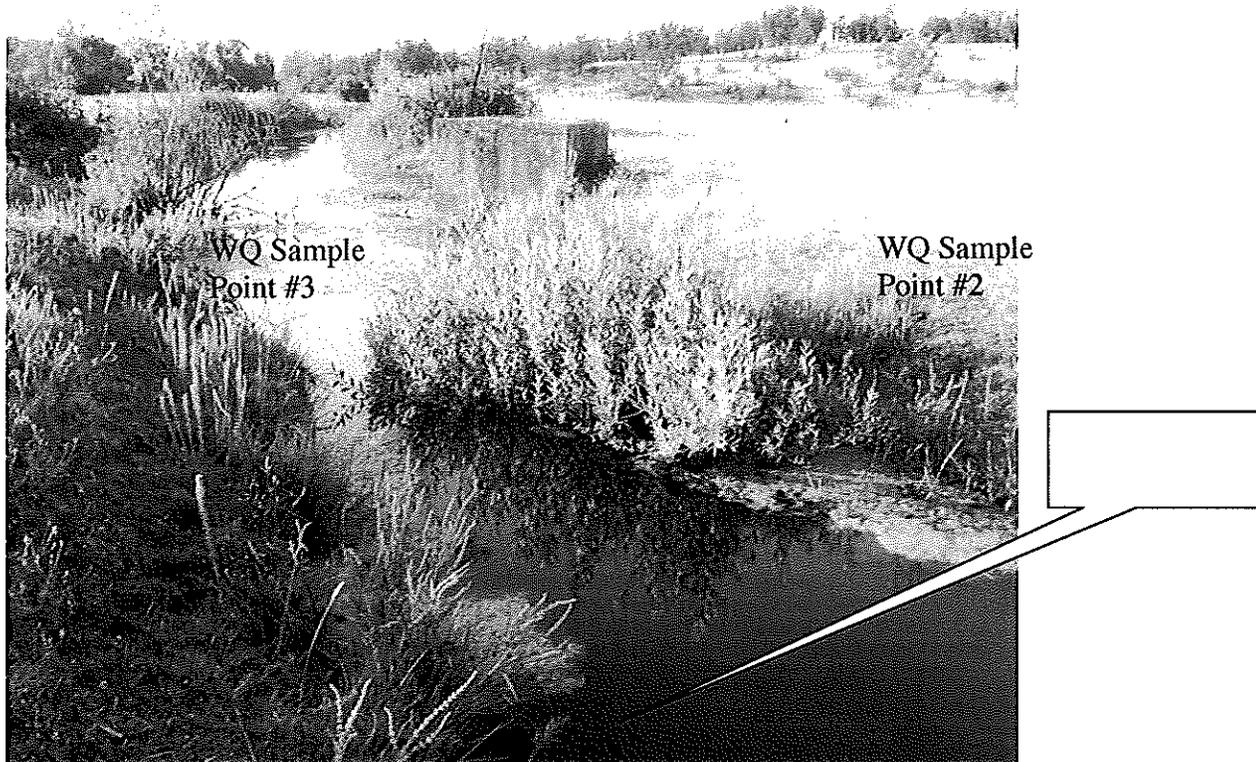
Photo #11: Beginning of slack water from dam where water quality sample #2 was taken.

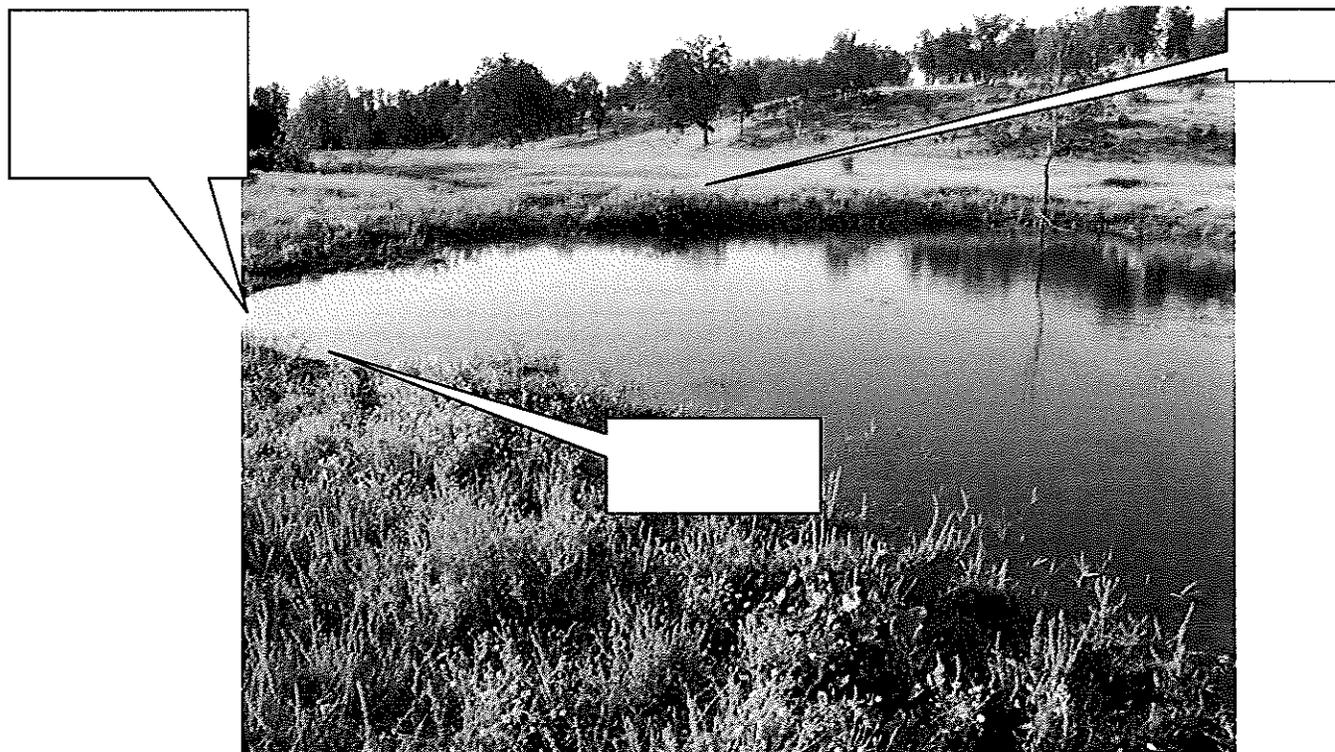
Photo #12: Dam on Dry Creek where water quality sample #3 was taken just before outlet of water around edge of dam. Water quality samples were taken at points #2 & #3 to determine input of *E. coli* at various points along the creek due to unrestricted livestock access.

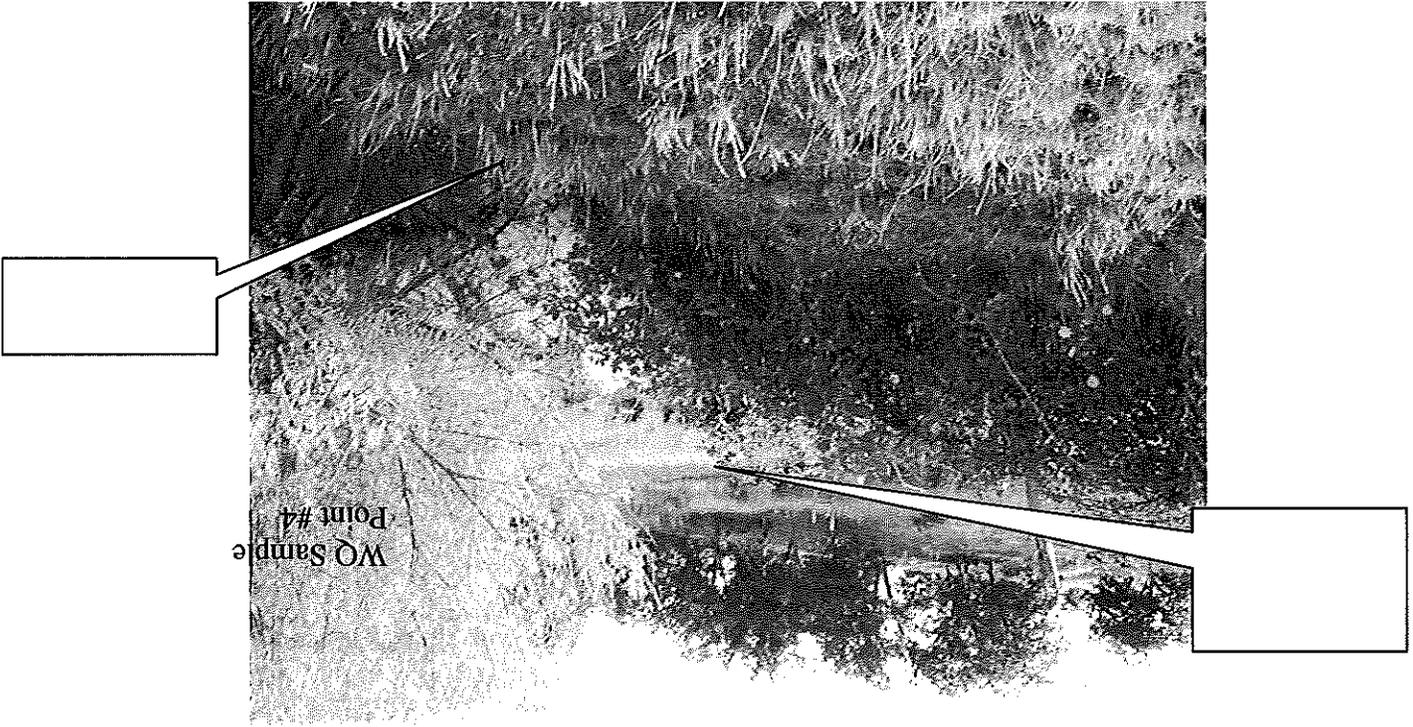
Photo #13: Near downstream edge of property line where water quality sample #4 was taken.

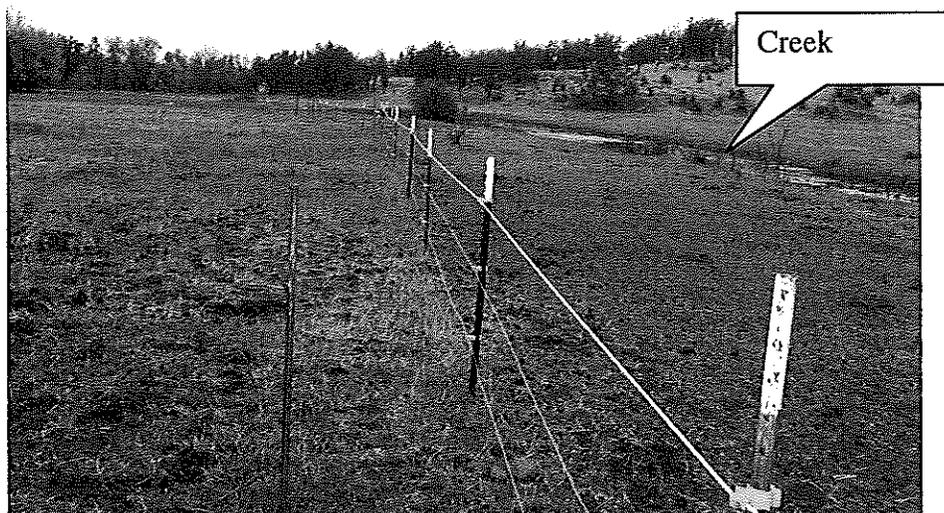
Photo #1: Looking northward along fence line with creek to the right.

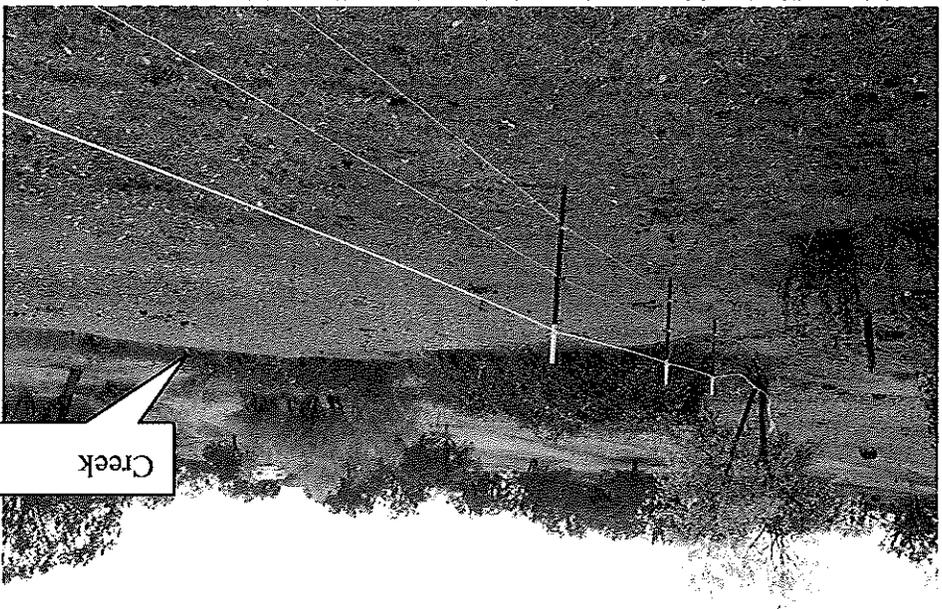
Photo #3: Looking northward along fence line with creek to right.

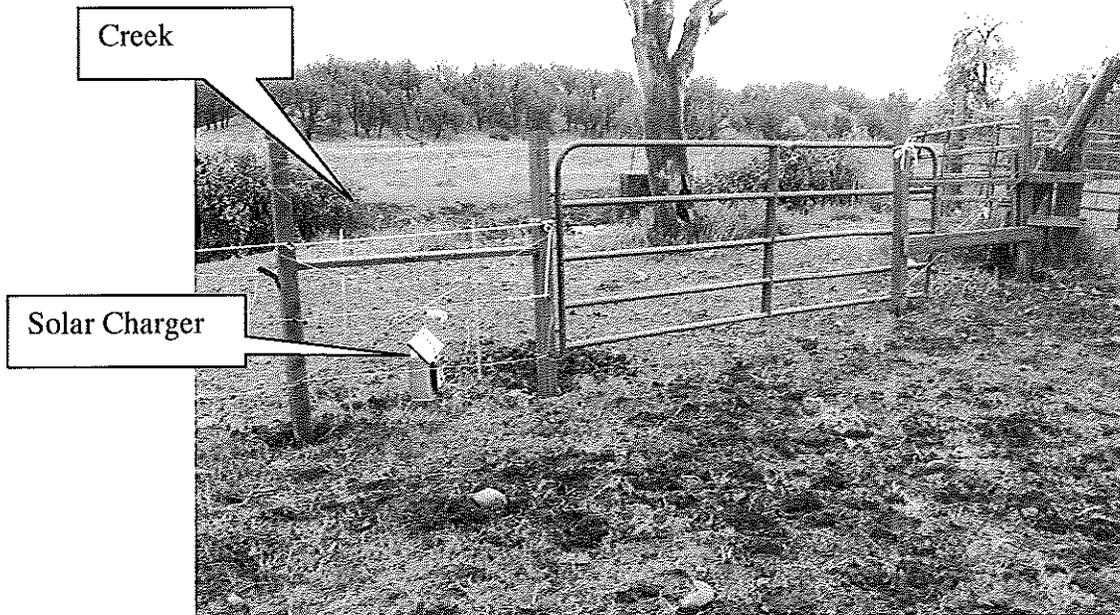
Photo #4: Looking eastward at gate to riparian area. Note solar charger for electrified fence.

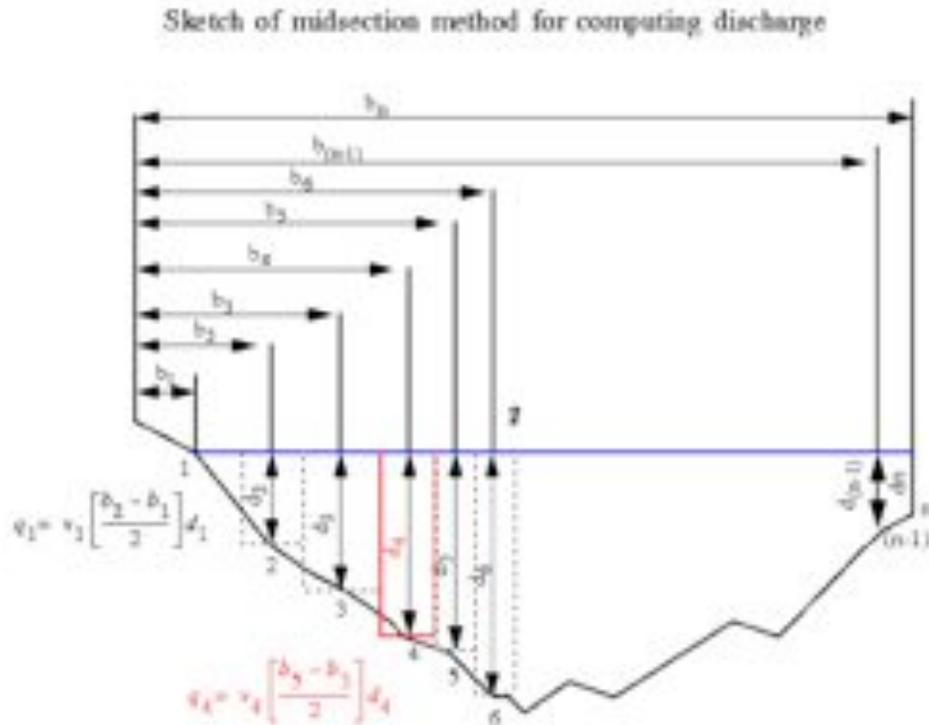
**Figure 1. USGS midsection flow measurement method (Western Washington University)**

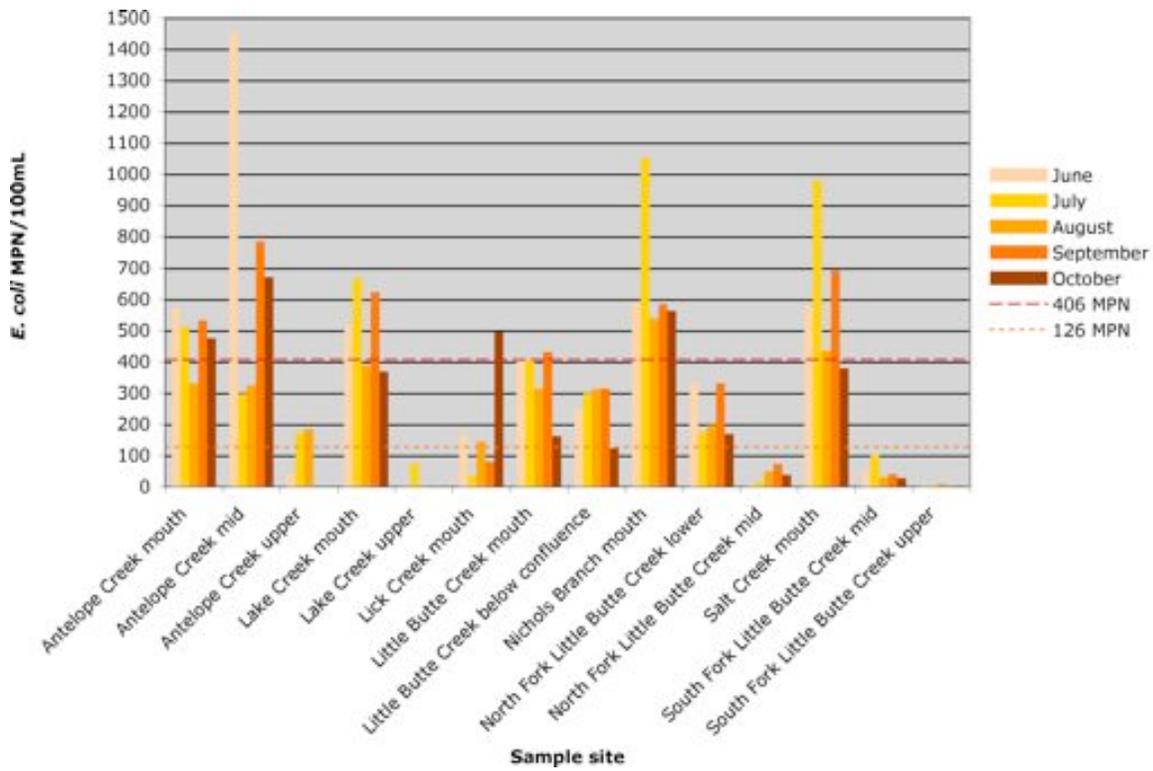
**Figure 2. Geometric mean *E. coli* MPN/100mL by month for sample sites (approximately 4 samples per month).**

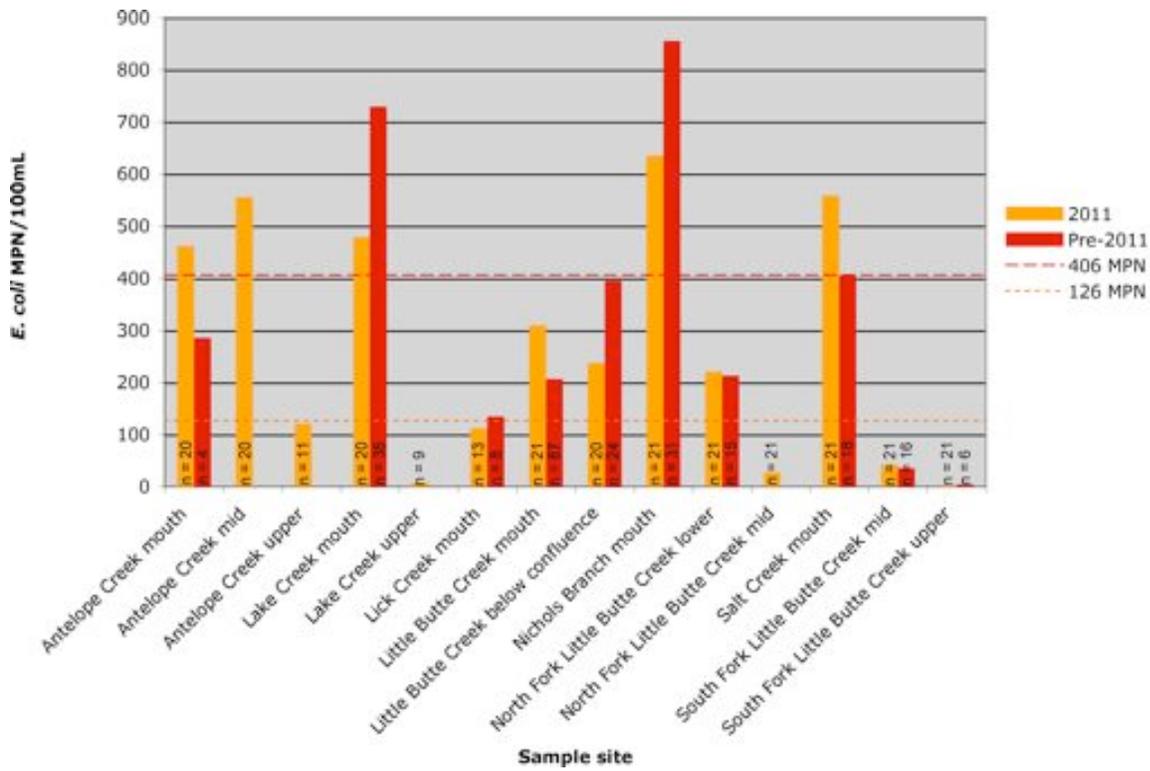
**Figure 3. Geometric mean for June-October 2011 *E. coli* MPN/100mL at sites, shown with June-October from years before 2011 for the same site where available.**

Figure 3 and Table 2 indicate the highest concentrations of *E. coli* to be found in Nichols Branch (636 MPN 100mL), Salt Creek (559 MPN/100mL) and Antelope Creek mid 556 MPN/100mL. The lowest concentrations were found at South Fork Little Butte Creek upper (1 MPN/100mL), Lake Creek upper 8 MPN/100mL) and North Fork Little Butte Creek mid (27 MPN/100mL). Table 2 lists sites in order of geometric mean *E. coli* MPN/100mL for study duration.

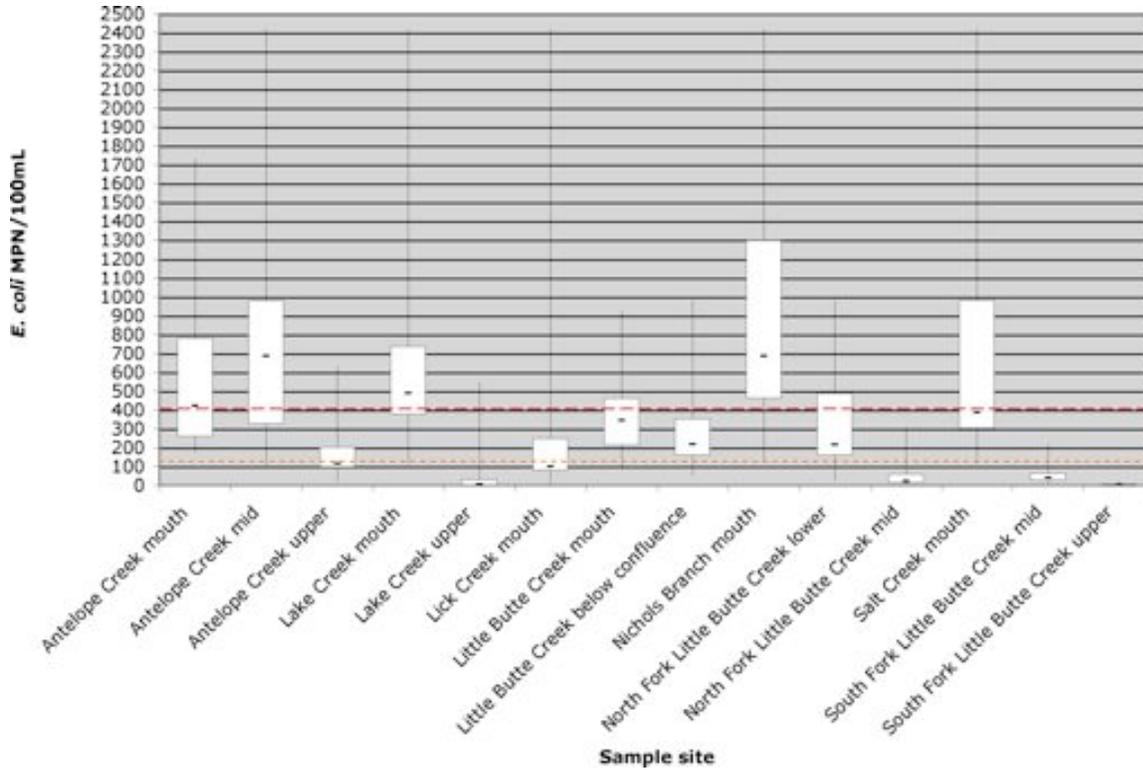
The range of values collected at each sample site varied widely. The values are represented in Figure 4 as IQR boxplots to better reflect the range of the data.

Figure 4. 2011 *E. coli* MPN/100mL per site in IQR boxplots for June-October.

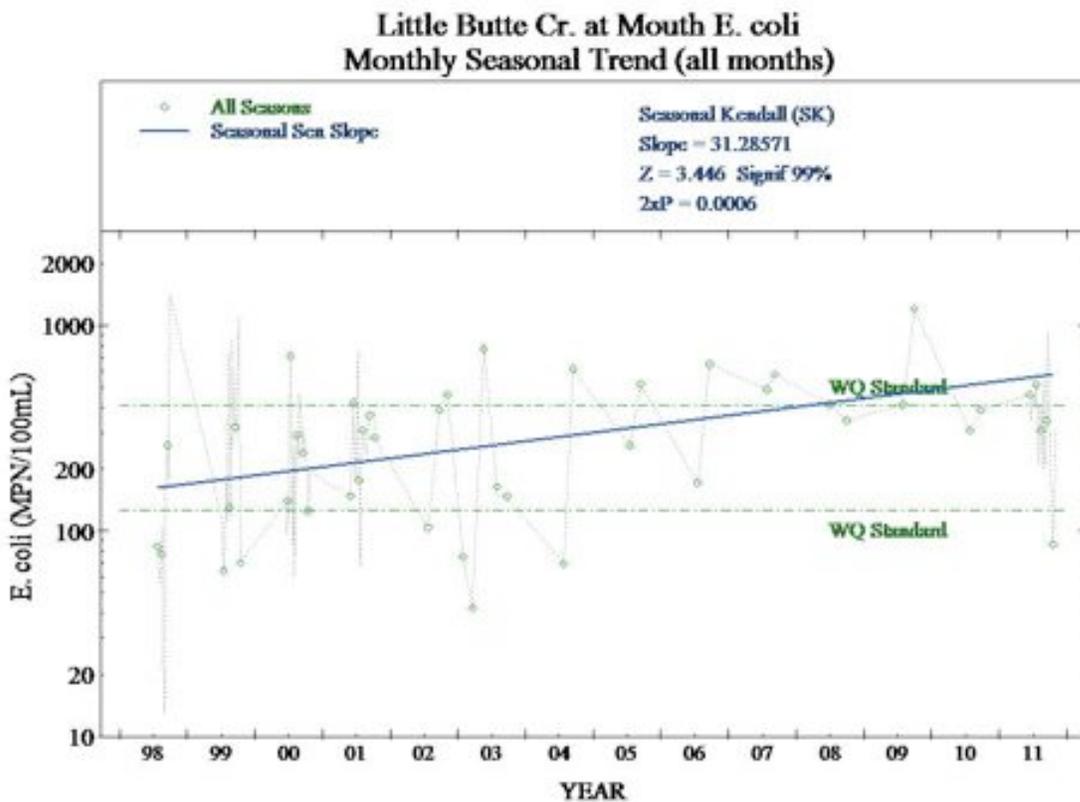
Figure 5 shows all *E. coli* data available from the LASAR database for the June through October range as well as the RRK data from 2011 for the mouth of Little Butte Creek with a plotted trendline. The data available shows that the levels of *E. coli* at the mouth of Little Butte Creek are trending upward since 1998. A seasonal Kendall test on the data using “Closest to Midpoint” aggregation returns a Z value of 3.446 and 2xP value of 0.0006, indicating a 99% confidence in an increasing trend. Additionally a slope of 31.28571 indicates that *E. coli* concentrations are increasing by approximately 31 MPN/100mL at this location per year.

**Figure 5. *E. coli* MPN/100mL results for the mouth of Little Butte Creek for all available data with trendline plotted (produced by Steve Hanson at DEQ Laboratory using WQHydro). Lower WQ Standard line is 126 MPN/100mL criteria, upper WQ Standard line is 406 MPN/100mL criteria.**

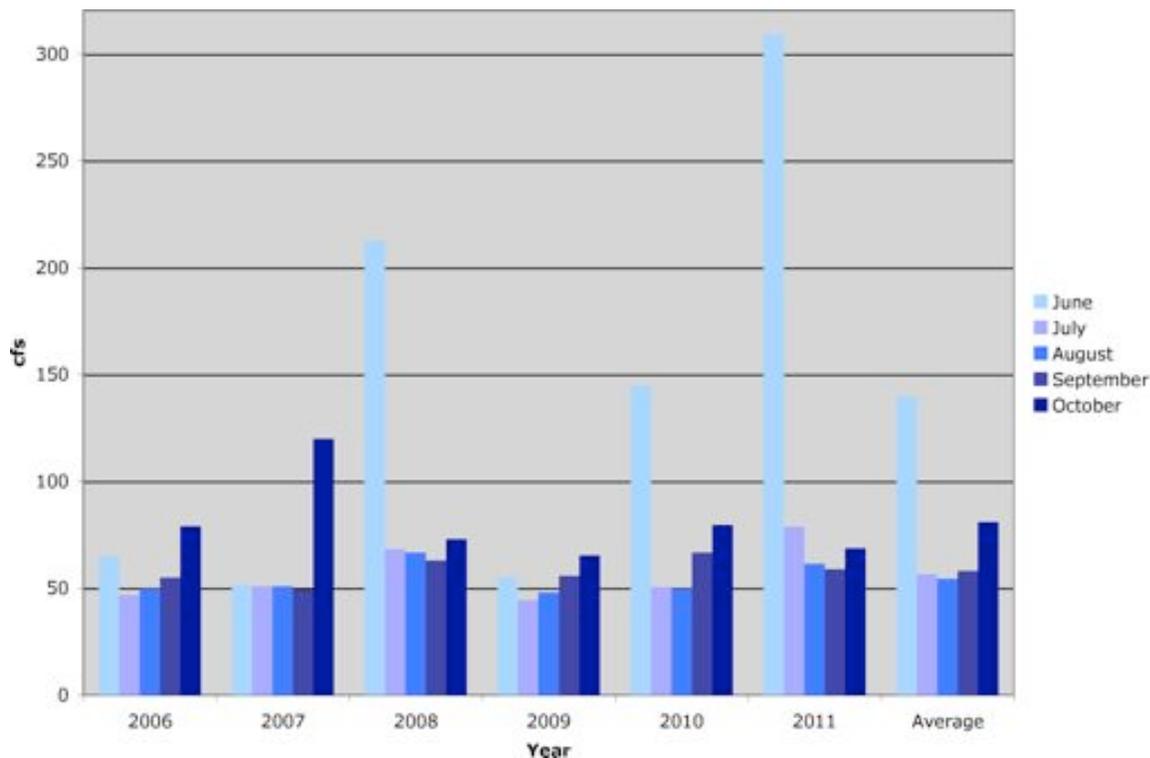
**Figure 6. Little Butte Creek mouth monthly flow average by year for 2006 through 2011.**

During this study period, the majority of streams had their peak flows in June.

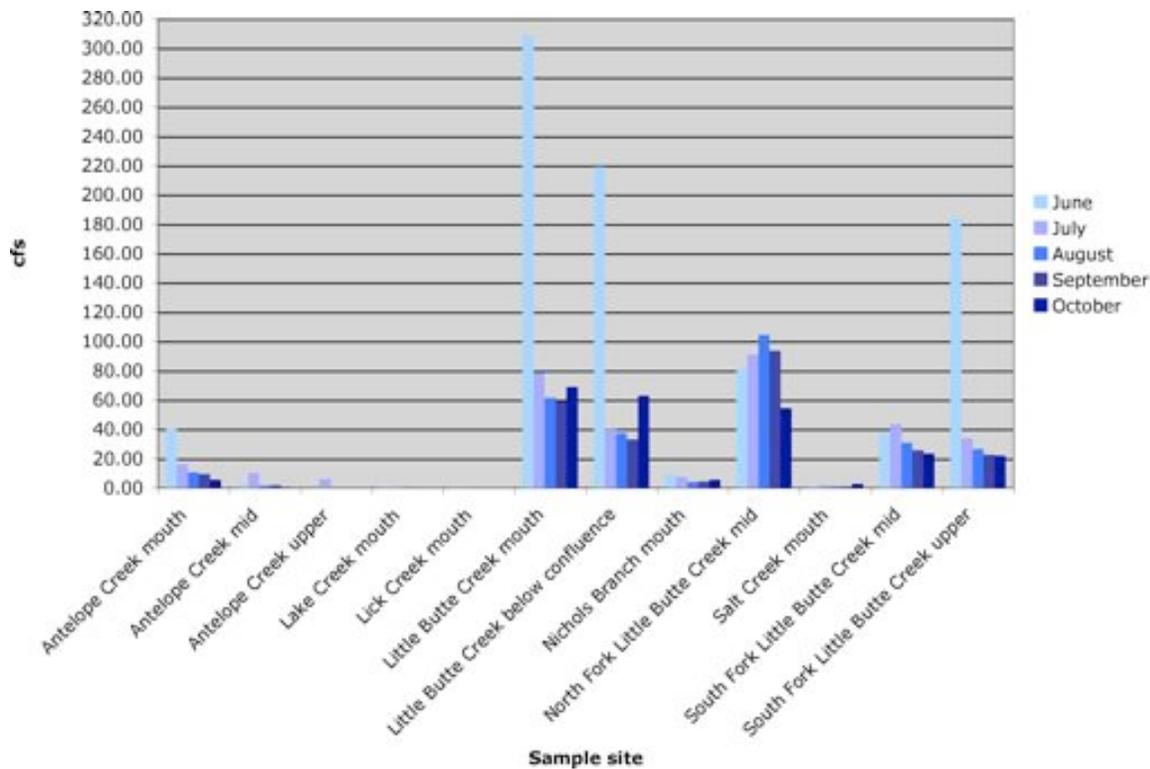
**Figure 7. Monthly average flow in cfs for each sample site where flow was recorded.**

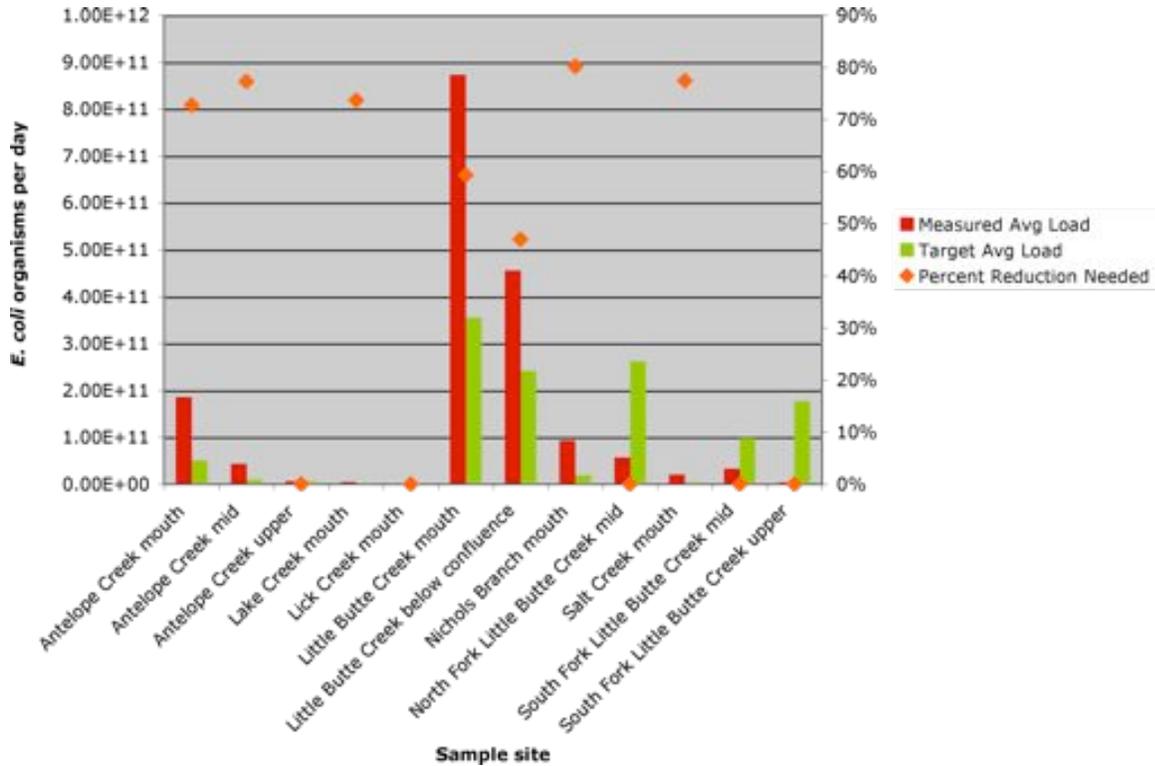
**Figure 8. Average *E. coli* organisms per day during sampling period (using monthly average flow and monthly geomean *E. coli* MPN/100mL), shown with the target average load for these flows at 126 MPN/100ml criteria and percent reduction in pollution to meet that target.**

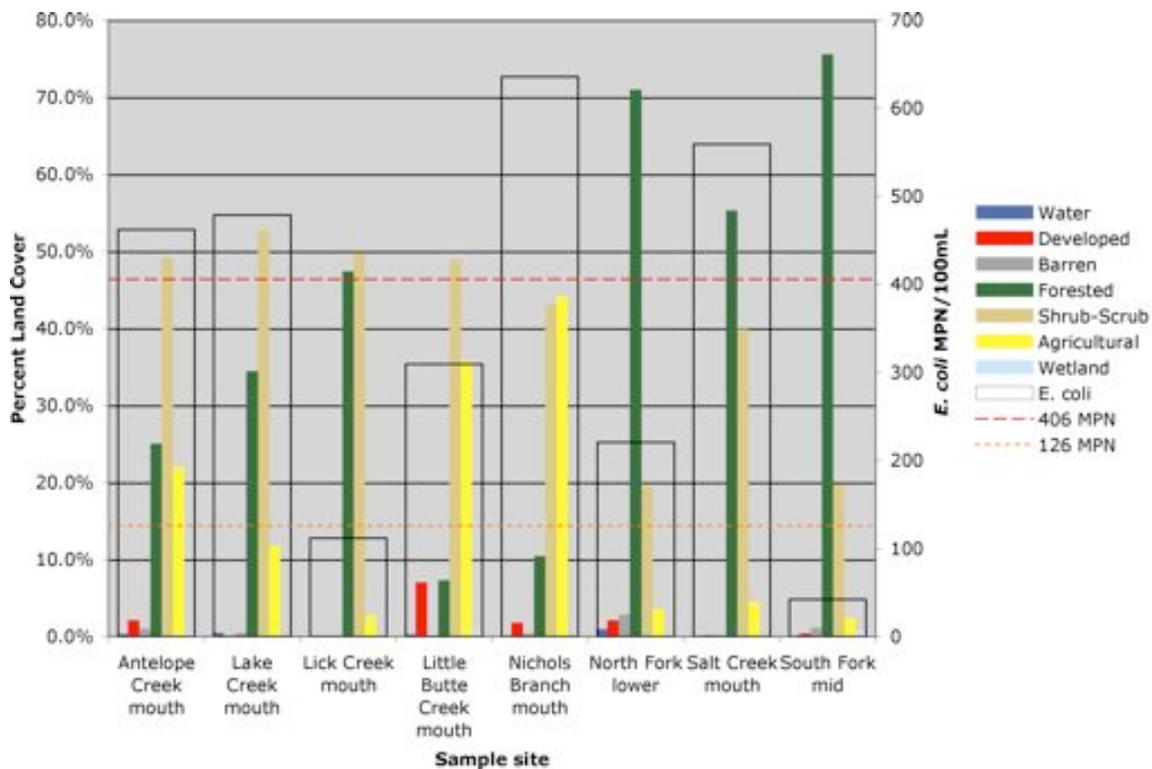
Figure 9. Land cover within watersheds defined for the lowest sample site per creek sampled shown with geometric mean of *E. coli* MPN/100mL for project duration at that site.
