**RE: NOAA, EPA seek public comment on proposal to disapprove Oregon's Coastal Nonpoint Pollution Program**

*Rogue Riverkeeper comments RE: NOAA, EPA seek public comment on proposal to disapprove Oregon's Coastal Nonpoint Pollution Program*

**Agriculture Water Quality Management Program  
Compliance Investigation Reporting Form  
CI5**

# Little Butte Creek Bacteria Study 2011

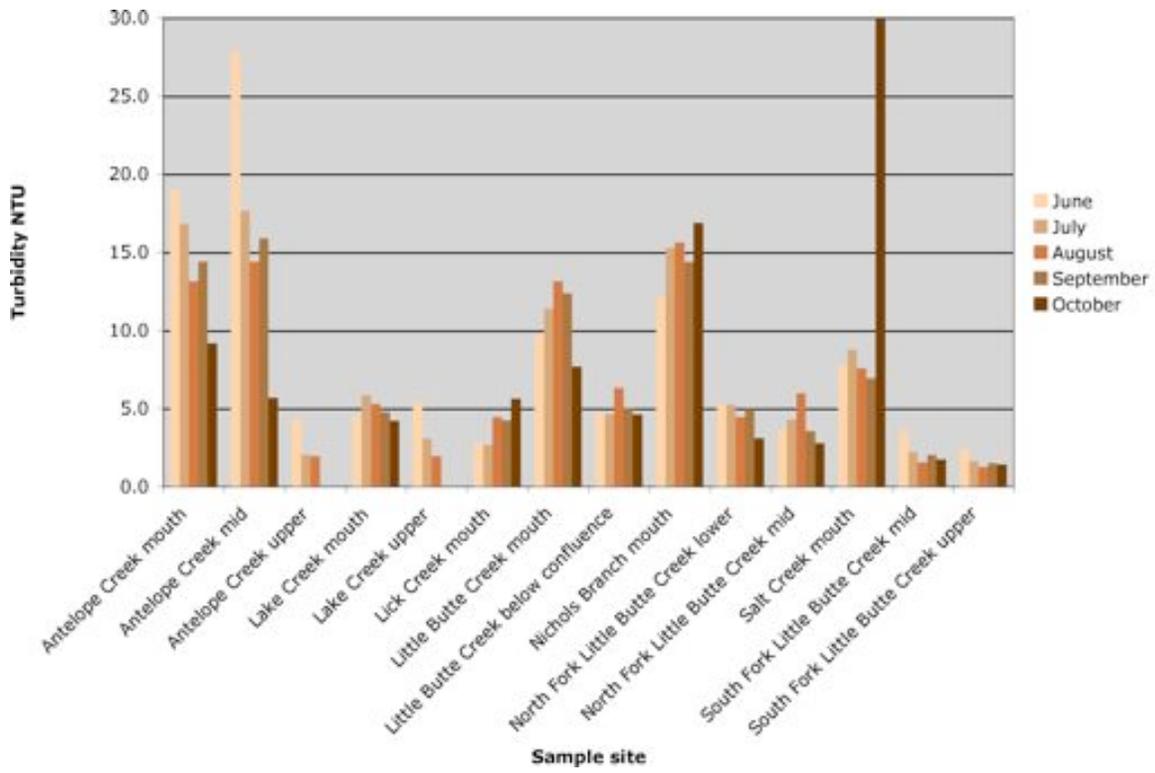
**Figure 10. Arithmetic mean turbidity in NTU by month for sample sites (note off chart value of Salt Creek is 173 NTU).**

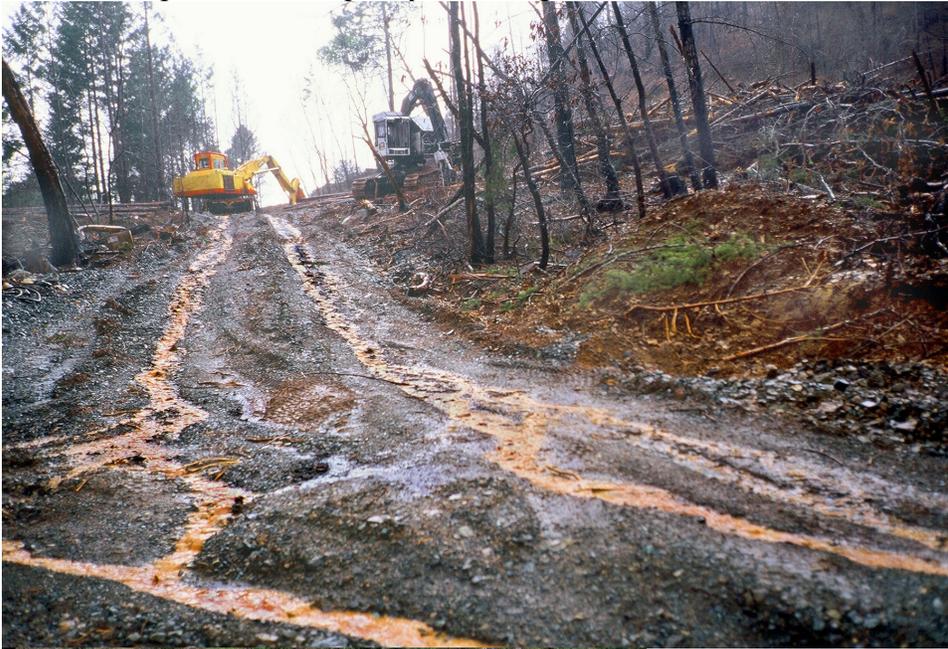
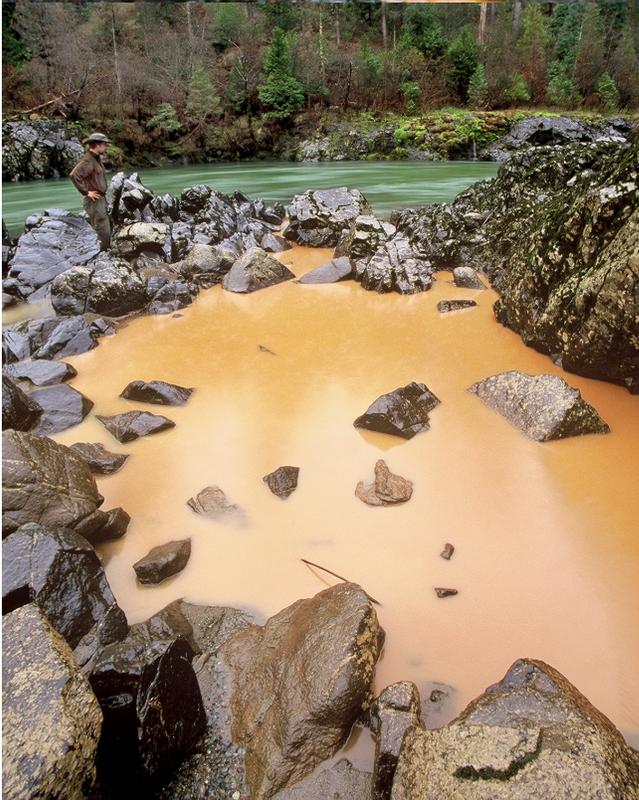
Private lands logging along the Illinois River in 2003. The harvest and road sediments pictured above are pictured reaching the Illinois River below. Siskiyou Project file photos.

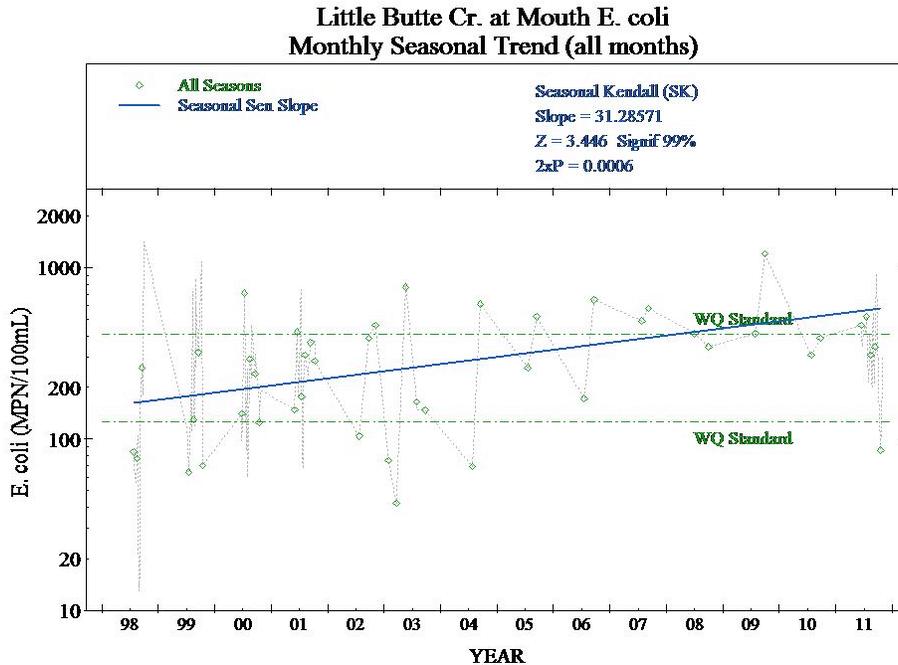
Figure 5. *E. coli* MPN/100mL results for the mouth of Little Butte Creek for all available data with trendline plotted (produced by Steve Hanson at DEQ Laboratory using WQHydro). Lower WQ Standard line is 126 MPN/100mL criteria, upper WQ Standard line is 406 MPN/100mL criteria.
